Model No.
Sea Sparrow

STRUCTURAL AND ENVIRONMENTAL
TEST REPORT
FOR THE
NATO SEA SPARROW
FOLDING WING PROGRAM

Report No.
BR-6253

Static structural, dynamic structural and environmental tests were conducted on the NATO Folding Wing Assembly and Torsion Bar. The Folding Wing Assembly and Torsion Bar successfully withstood structural and environmental tests which were conducted under this program.

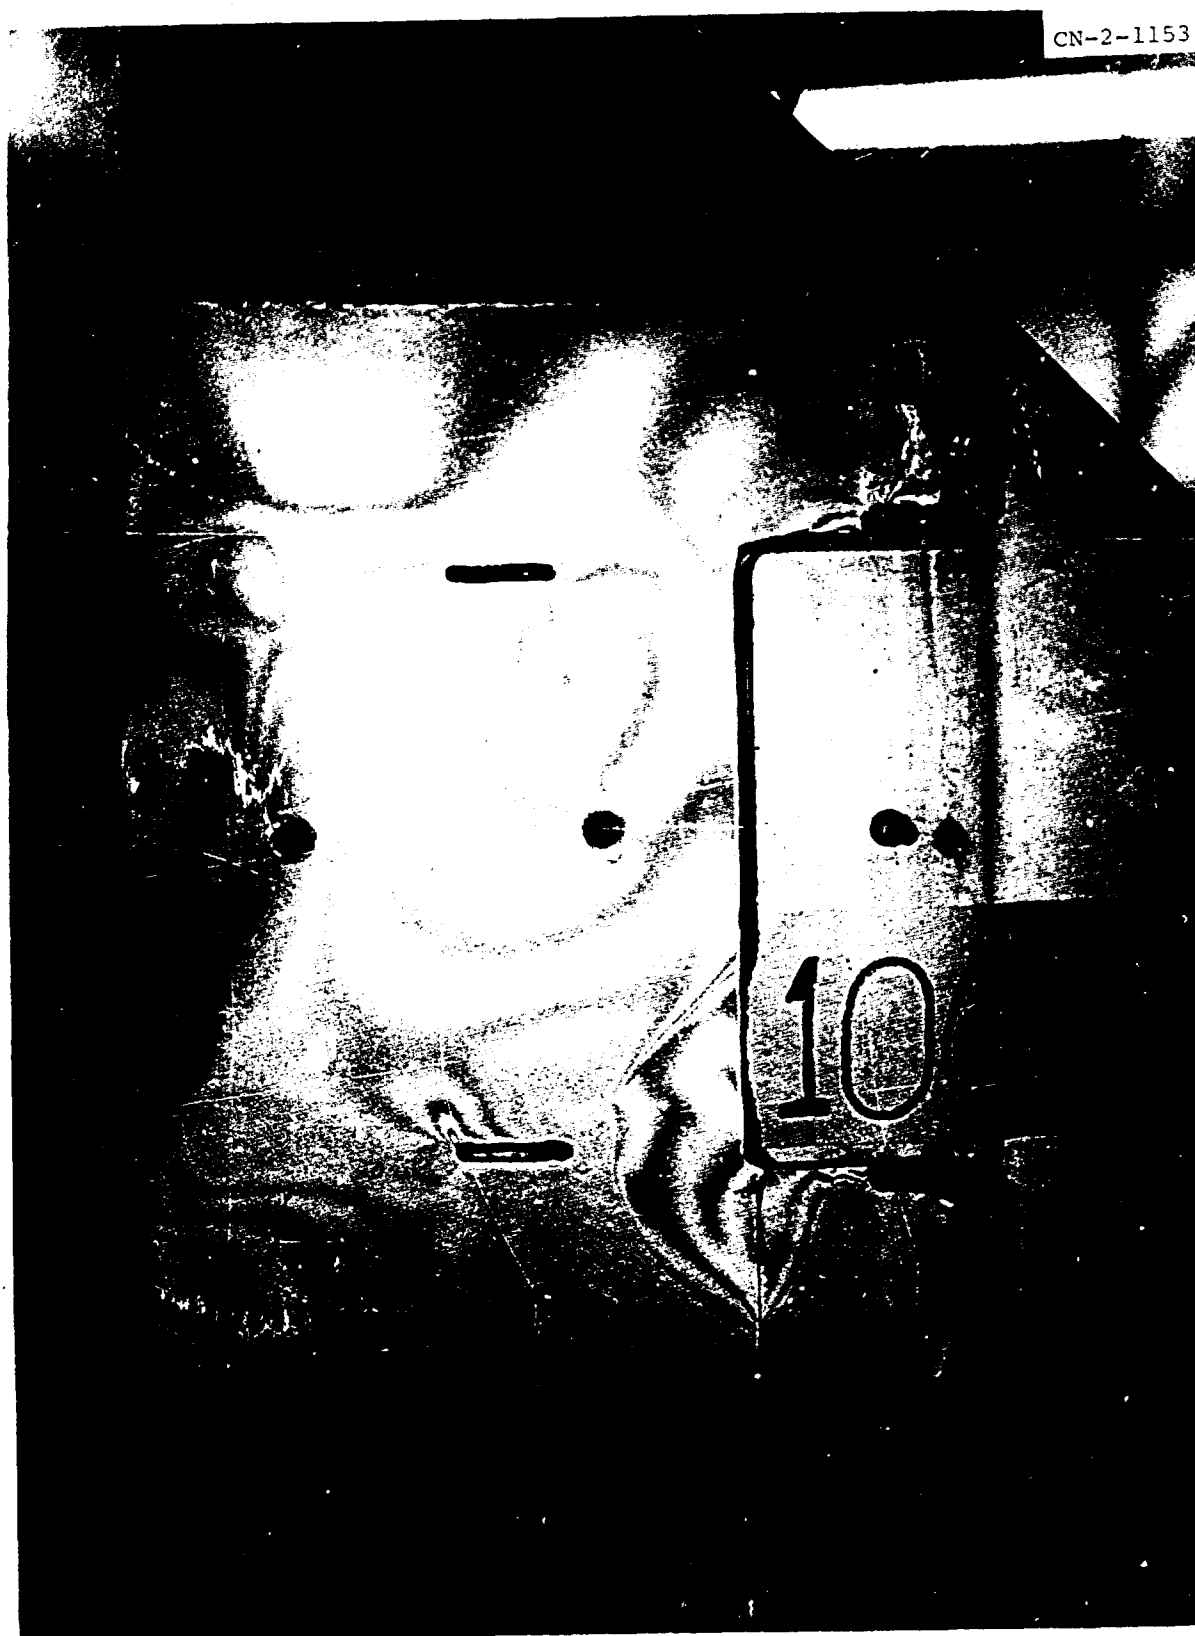
Static Load Test No. 2 - 100% Limit Load

Photographs of the developing stress pattern were taken at 30%, 50%, 70% and 100% of the temperature corrected design limit load. Those photographs are shown on pages 1.3.9, 1.3.10, 1.3.11 and 1.3.12, respectively. Unfortunately, the photoelastic material developed a crack at the highly stressed aft corner after 50% design limit load had been attained. However, the photographs do show the general overall picture of how the stresses developed throughout the inner panel.

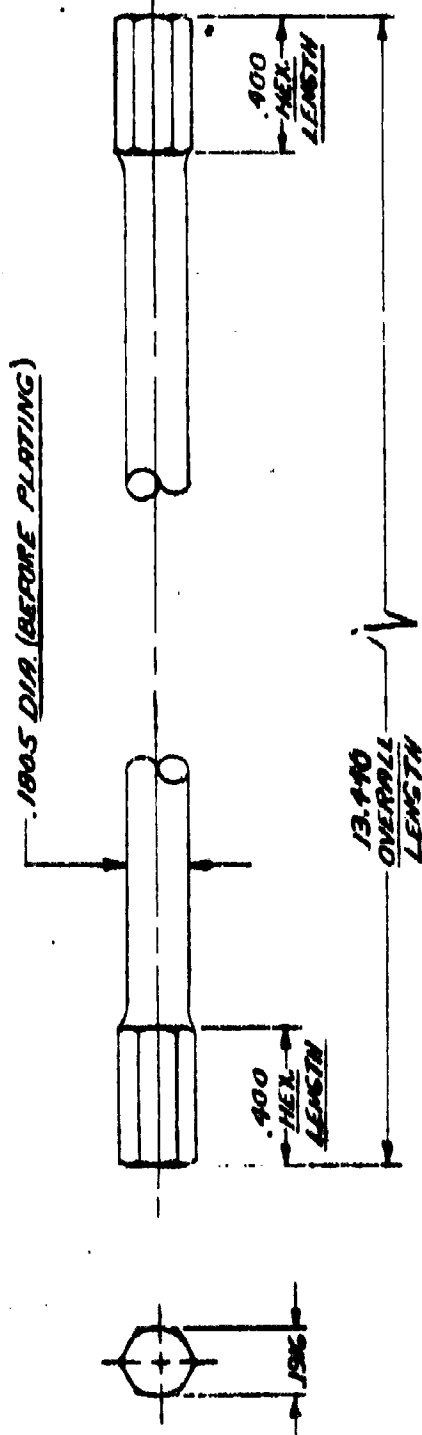
FIGURE 7

TORSION BAR

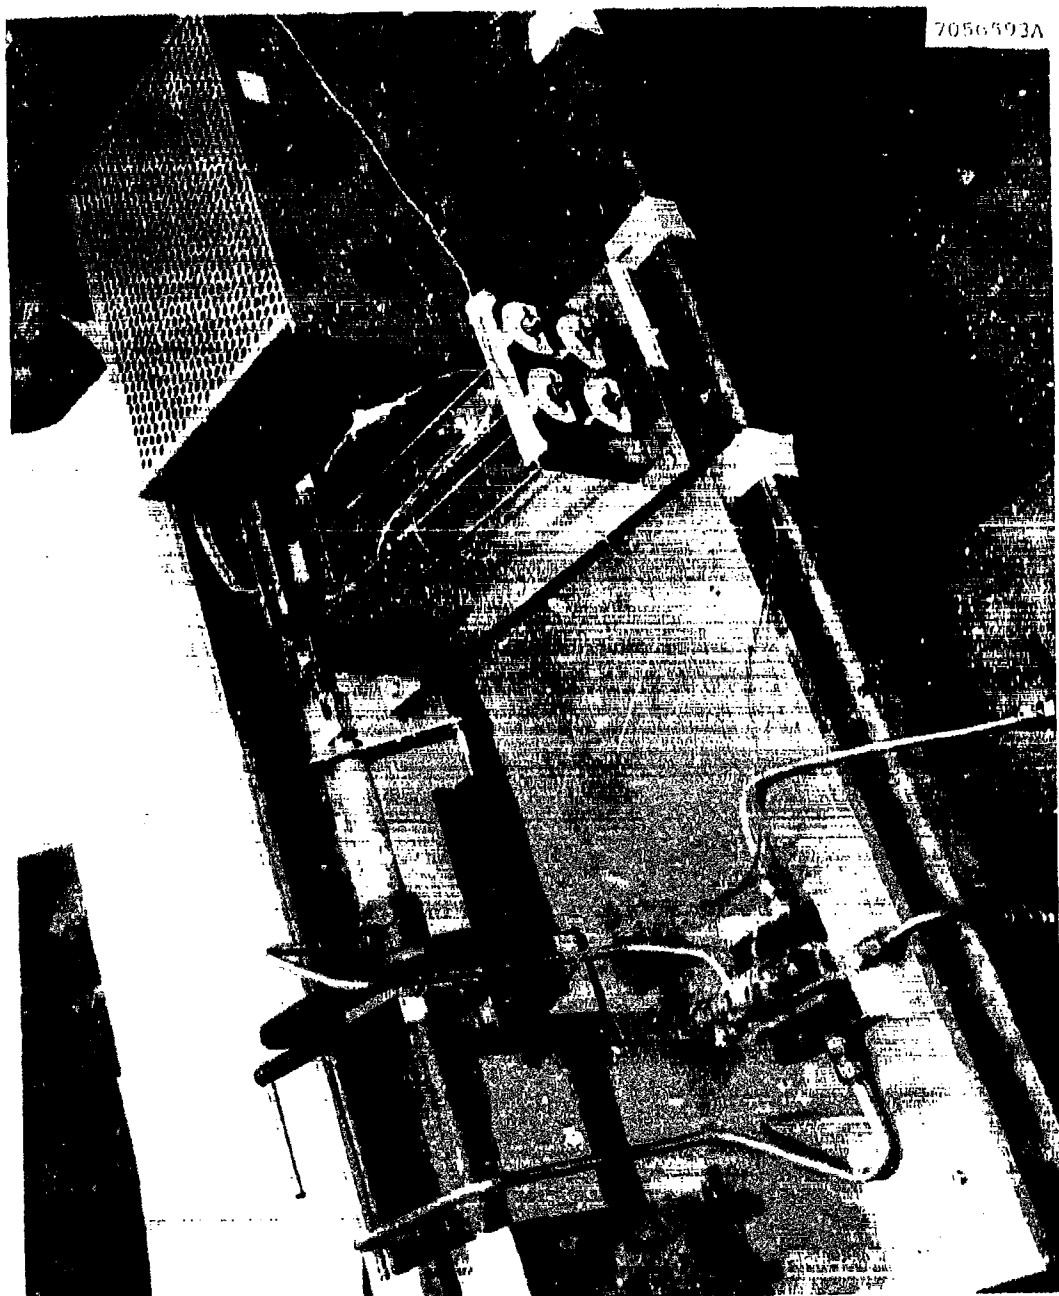
Torsion Bar Endurance and Relaxation Test Setup

specific pre-set angles. The torsion bars were cycled at the maximum outer wing panel rotation of 135 degrees at a frequency of 0.1 cycles per second. At each half-hour interval, until failure occurred, the endurance test was stopped and the torques required to twist the torsion bars to the specific angles required to attain the selected stress levels were measured and recorded for each torsion bar.

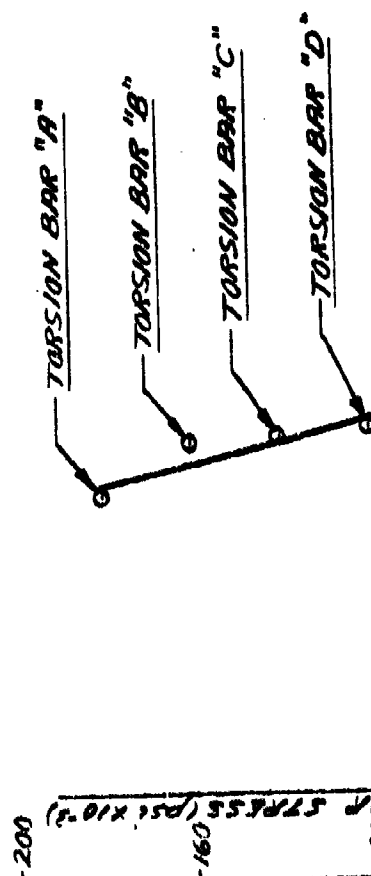
SN CURVE - MAX. TORSIONAL SHEAR STRESS
VS. NUMBER OF CYCLES TO FAILURE

TORSION BAR MATERIAL - 1890 NICKEL MARRAGING
ALLOY STEEL, GRADE 350, RC 57-61

Four torsion bars were tested and a table of the test results is shown on page 1.4.7. Also, a S-N curve of the maximum torsional shear stress vs. the number of cycles to failure is shown on page 1.4.8.

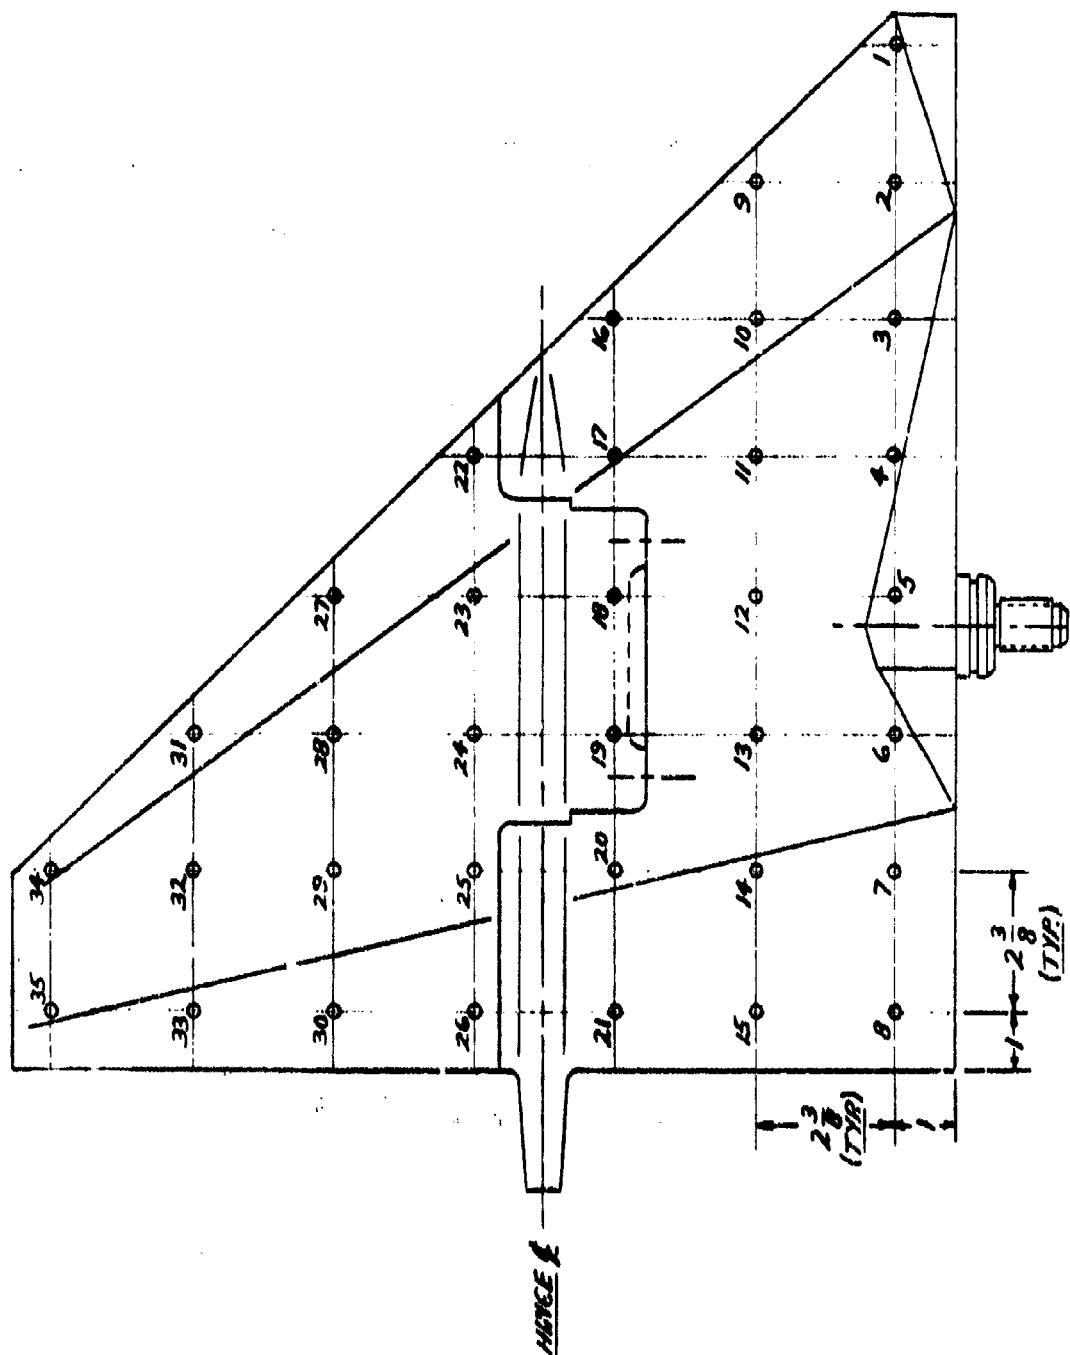
INFLUENCE COEFFICIENT STUDY-LOAD & DEFLECTION PT. LOCATIONS
FIGURE 8

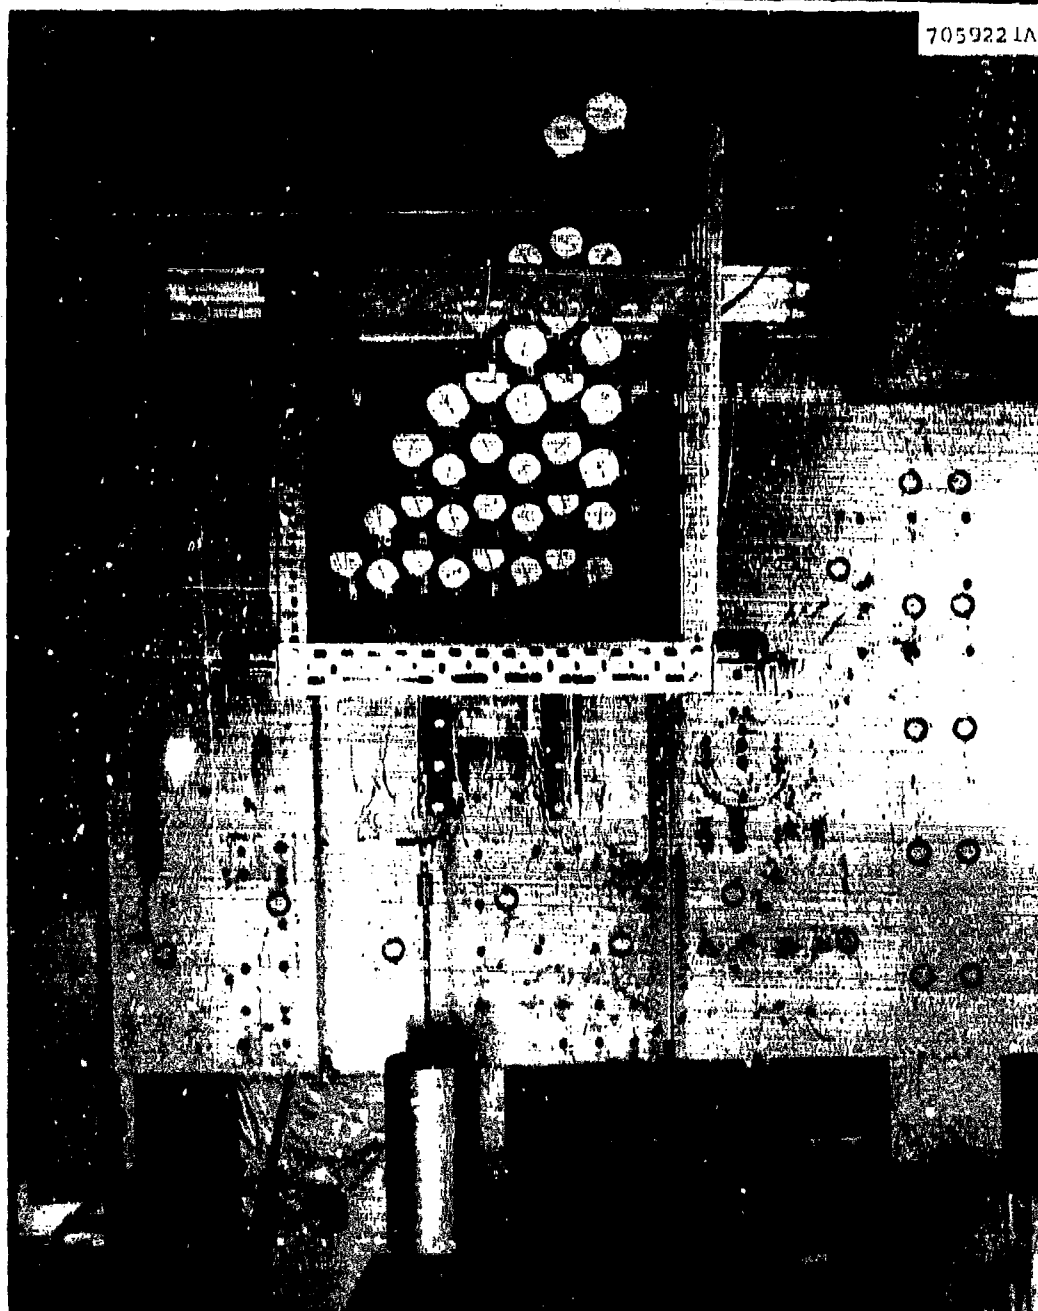
Influence Coefficient Study - Test Setup - Overall View

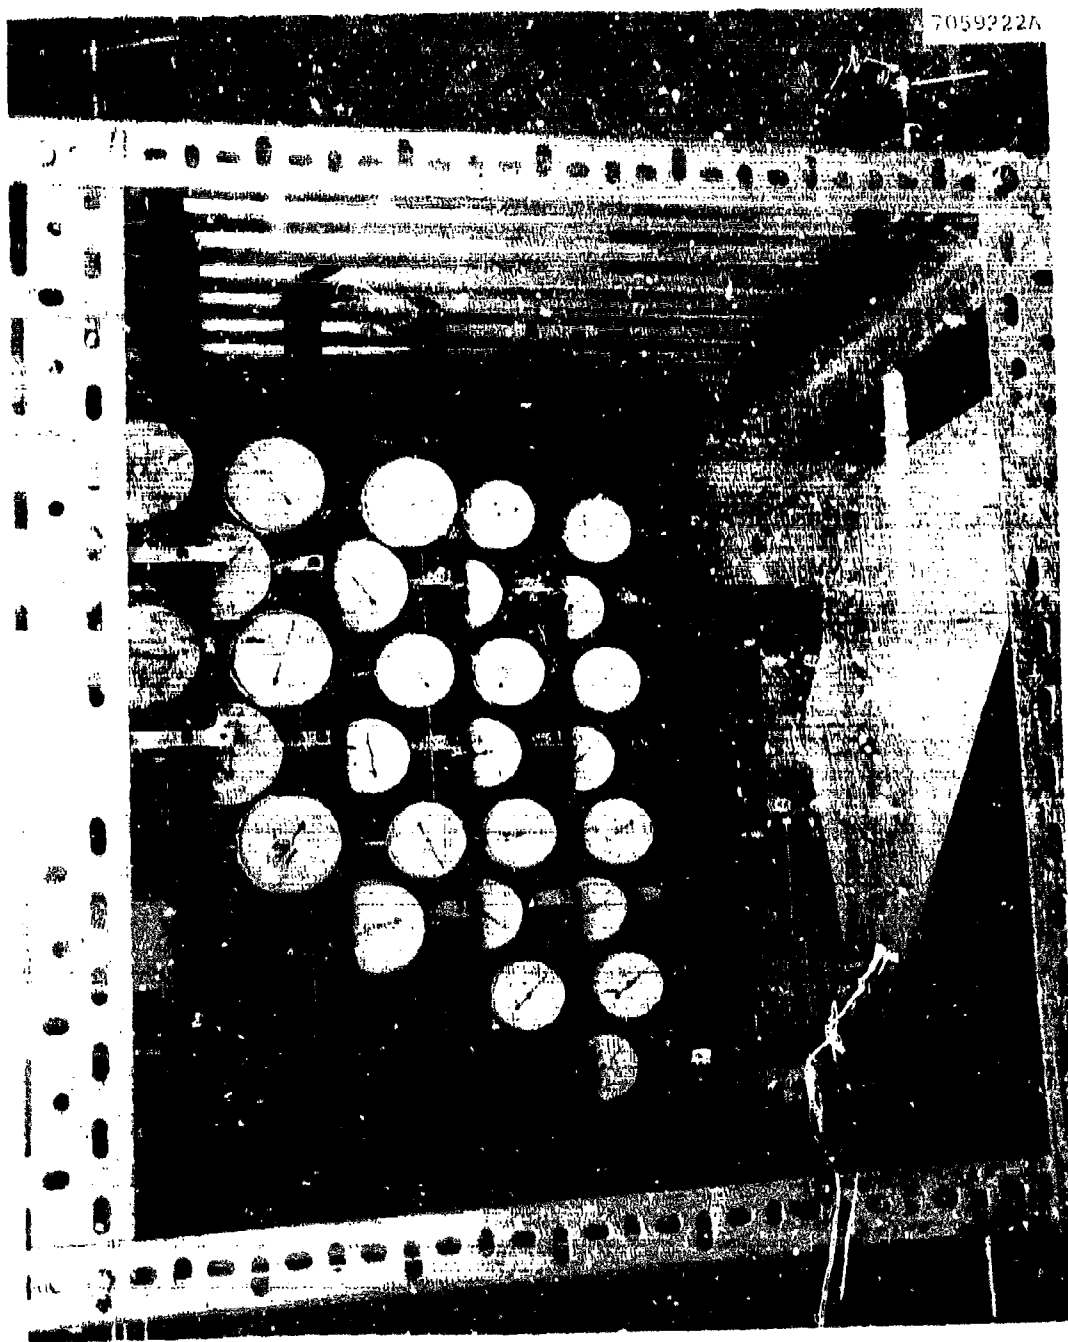
Influence Coefficient Study - Test Setup - Top View

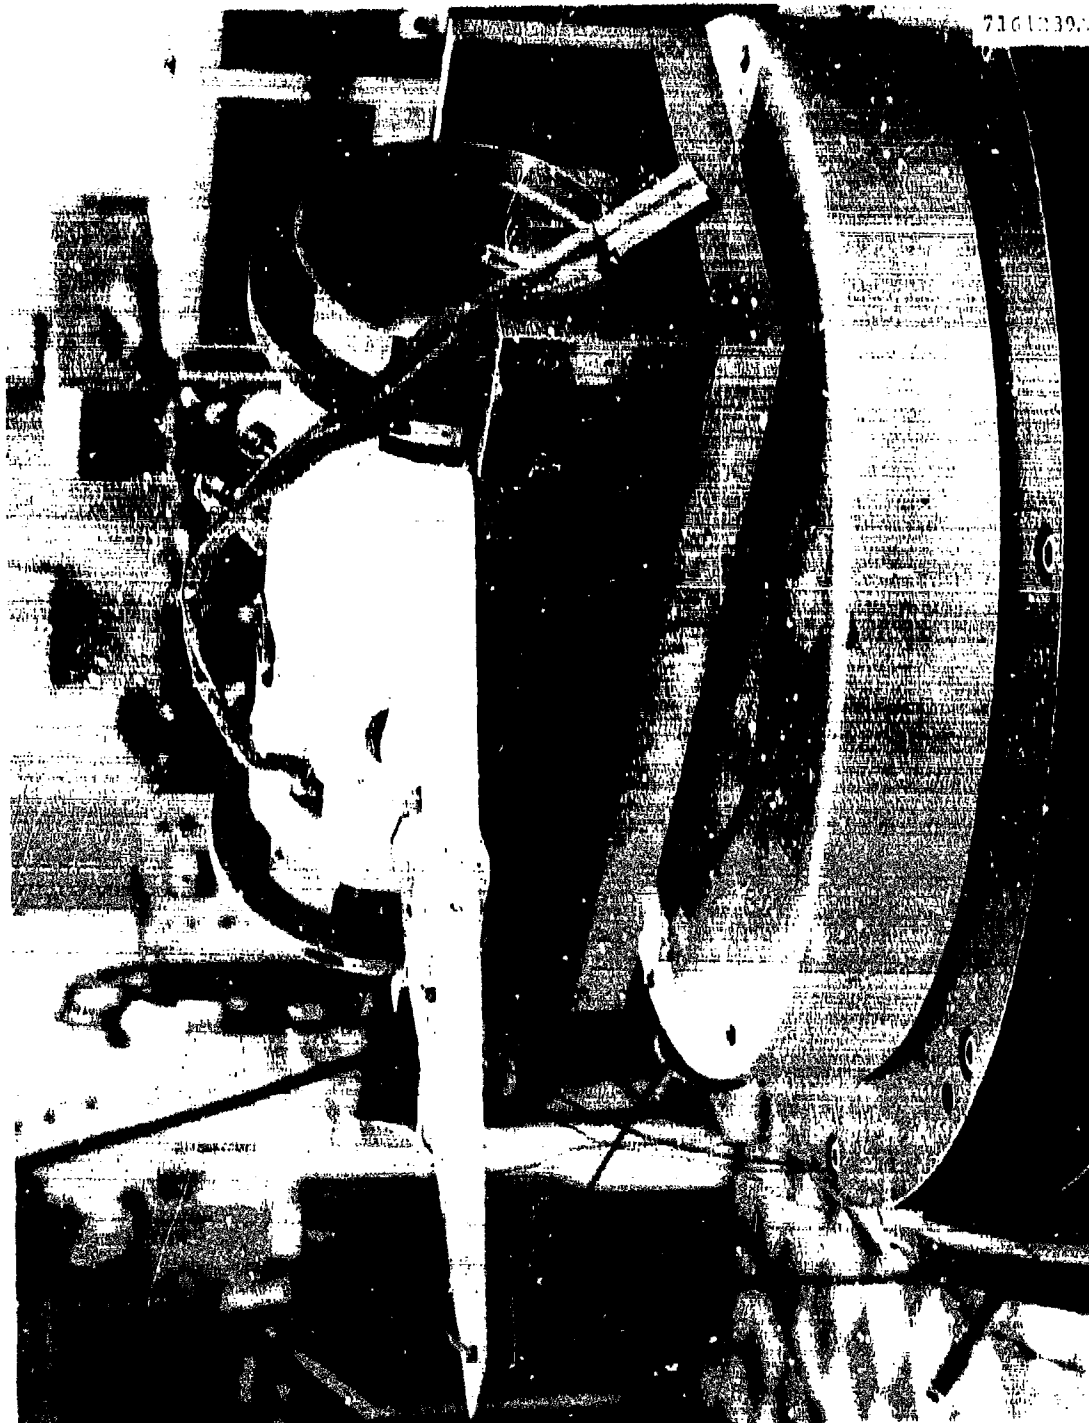
7161239

Random Vibration Test - Vertical Axis

Visual inspections of the folding wing were made after each of the random vibration tests. In each case no visual damage was evident.

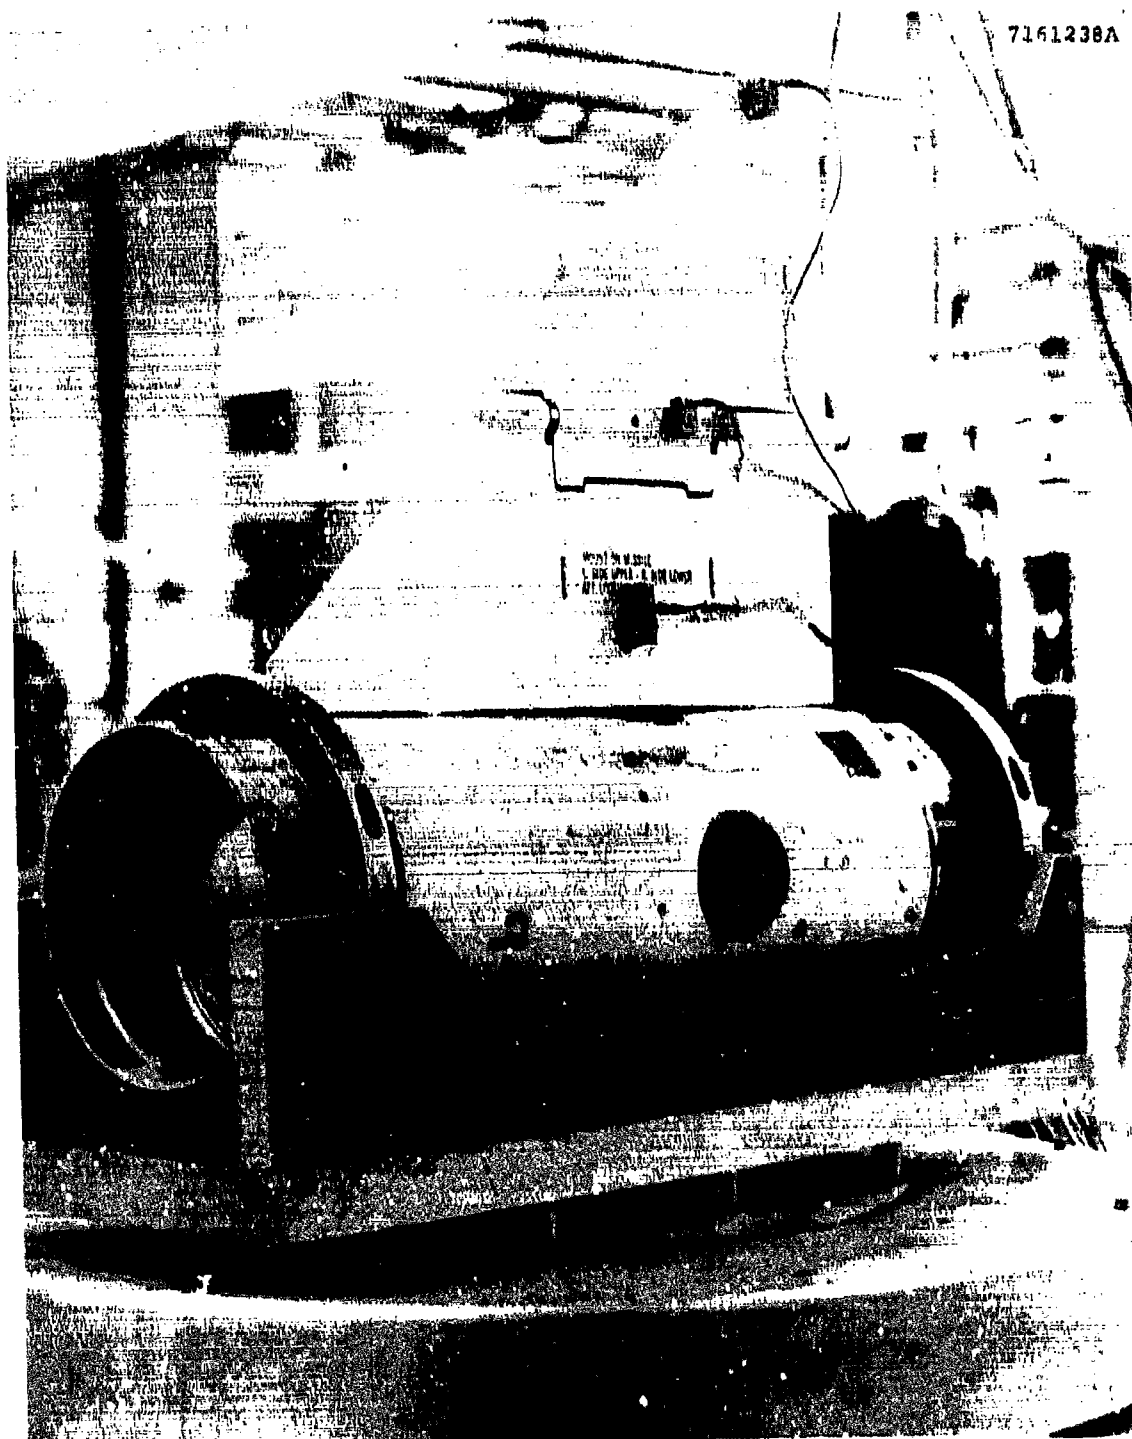
Random Vibration Test - Lateral Axis

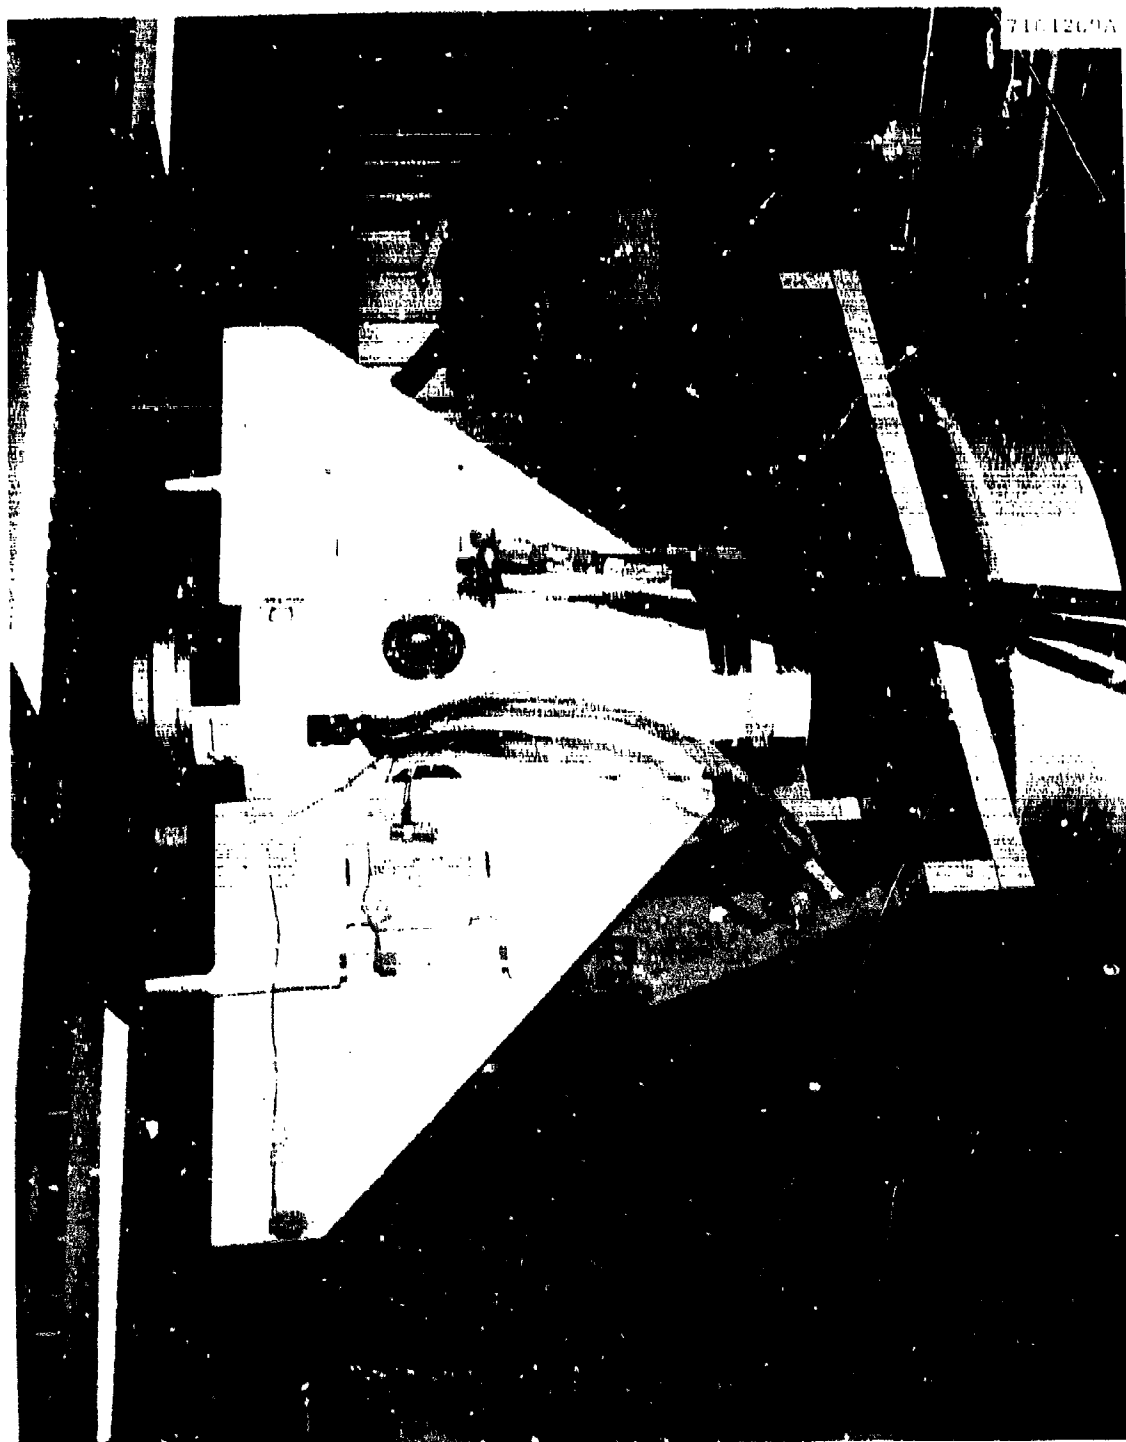
Random Vibration Test - Longitudinal Axis

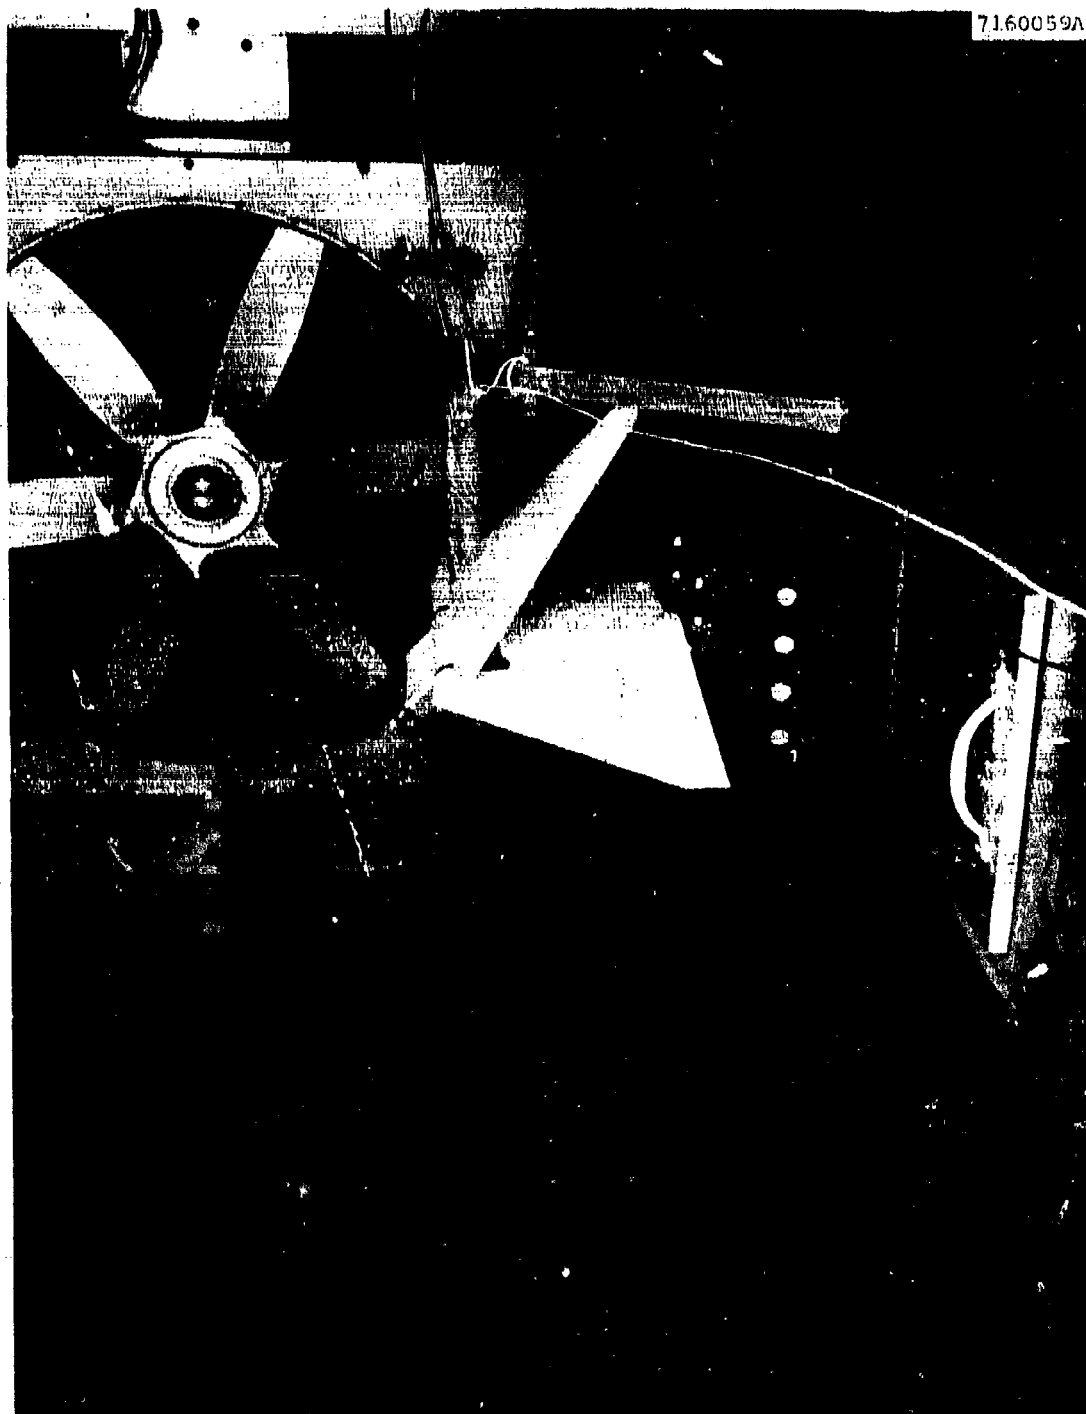
Temperature - Humidity Test Setup

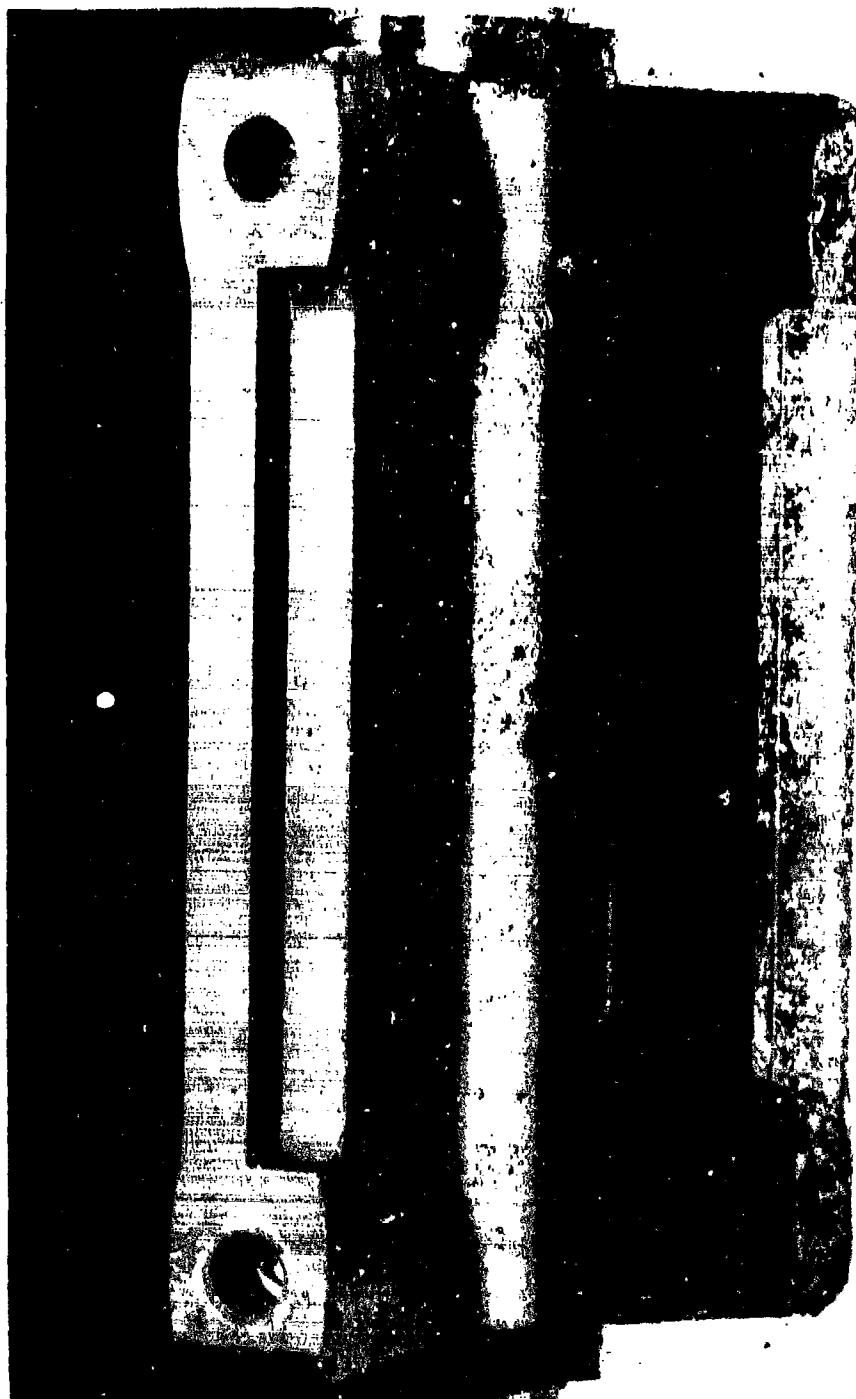
7163139A

Closeup of Modified Folding Wing After Salt Spray and Temp. - Hum. Tests

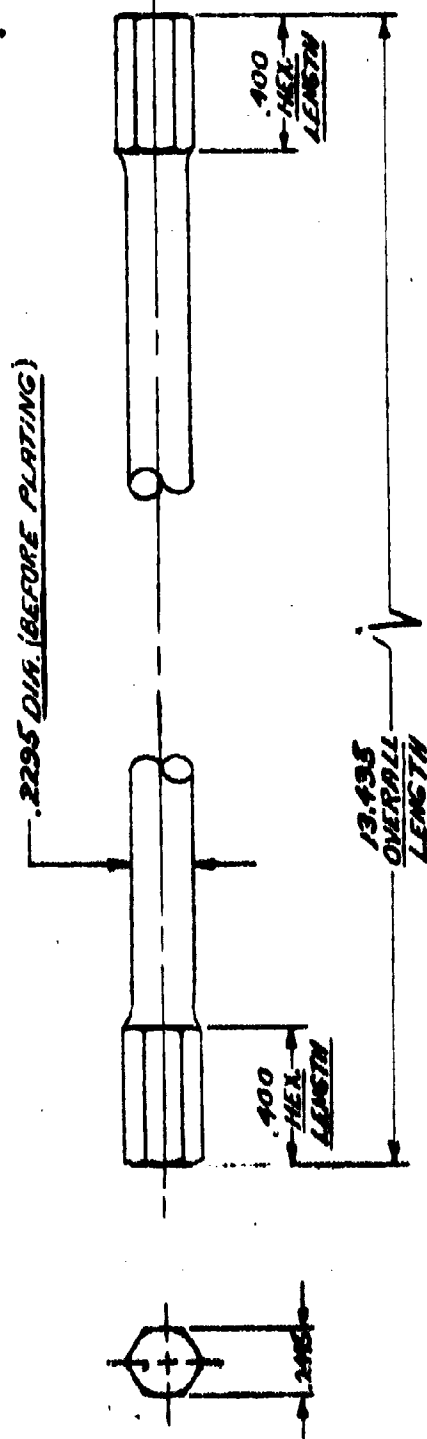
FIGURE 9

TORSION BAR

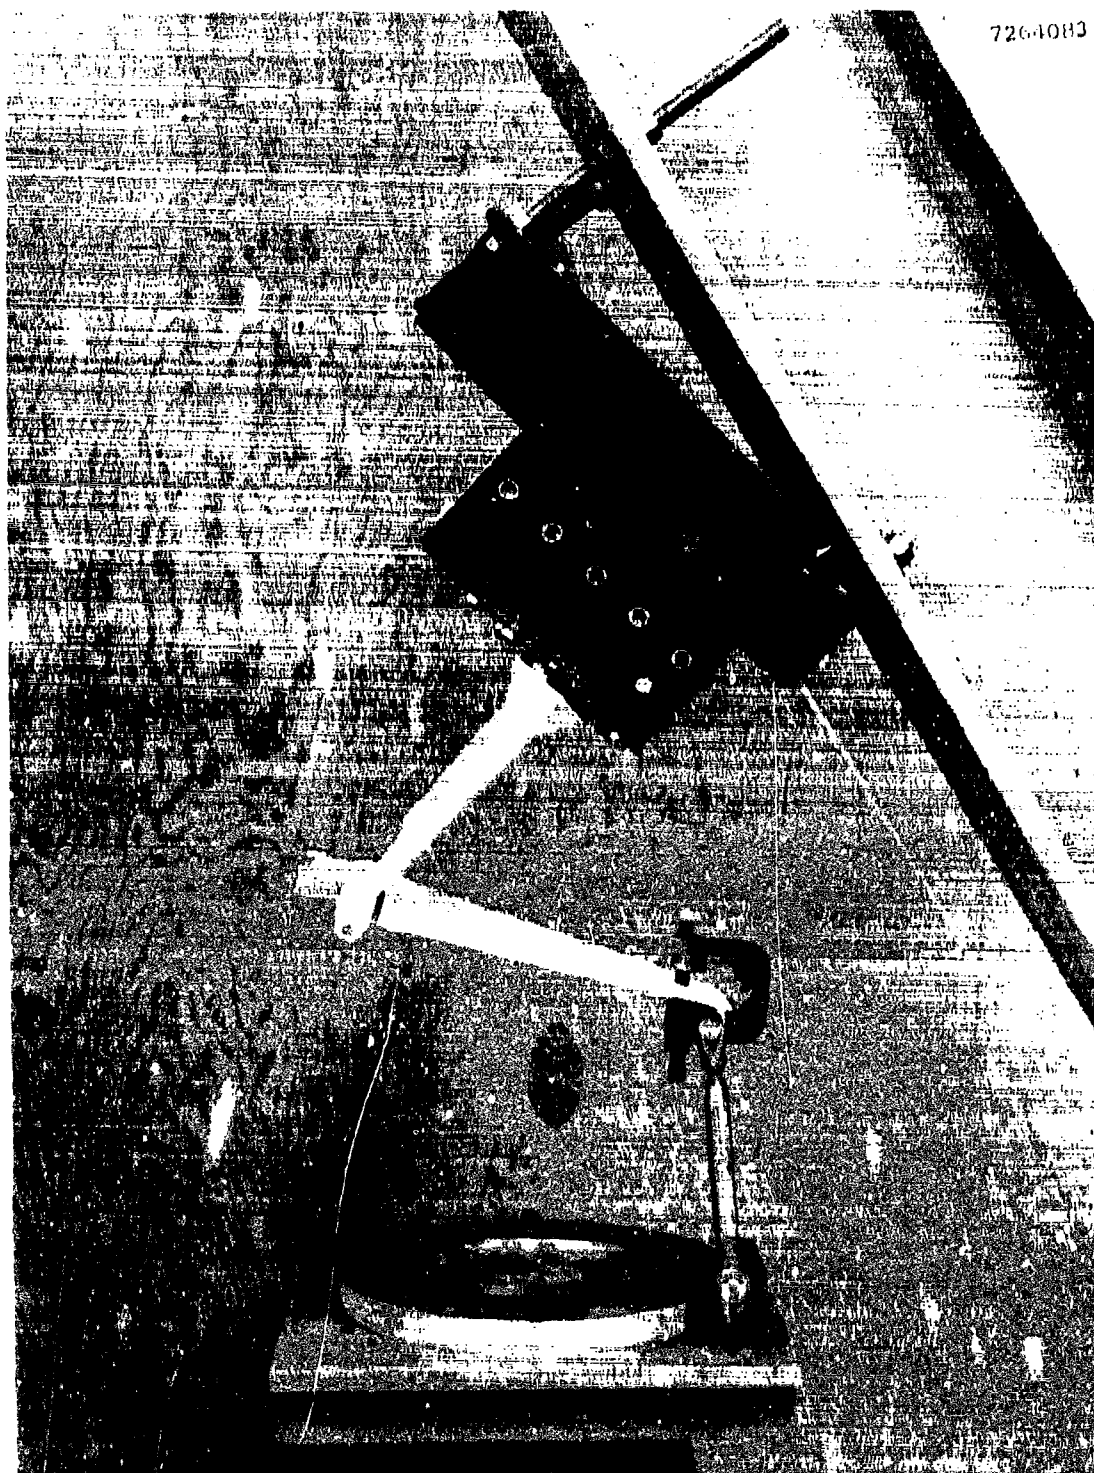
Torsion Bar Endurance Test Setup .
